PISCATAQUA RIVER BASIN
NOTTINGHAM , NEW HAMPSHIRE

DROWN'S DAM
NH 00136

PHASE I INSPECTION REPORT
NATIONAL DAM INSPECTION PROGRAM

JULY 1978

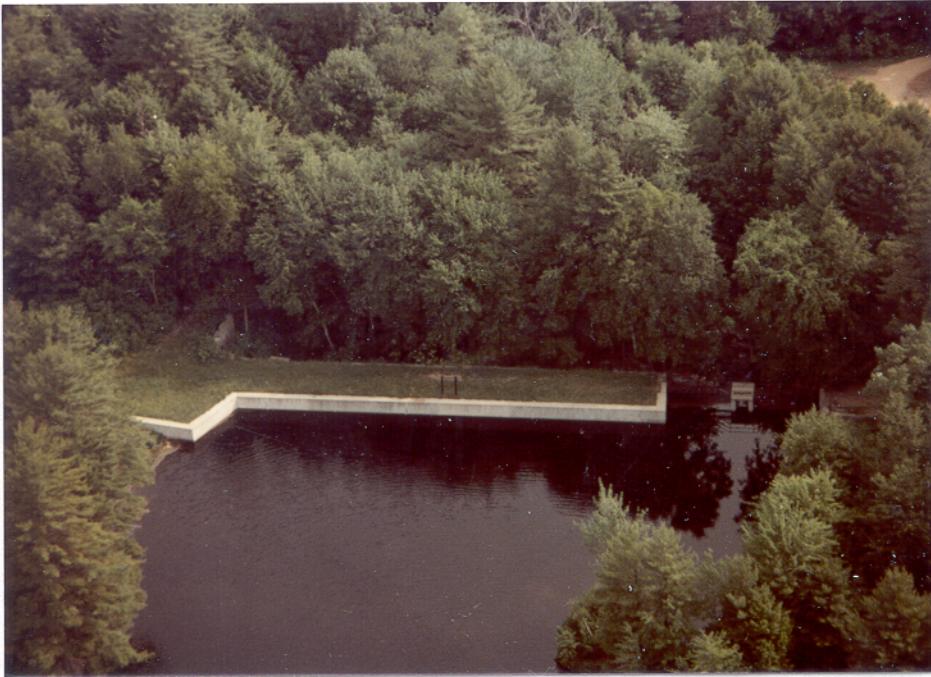
Figure 1 - Overview of upstream face of
Drown's Dam.

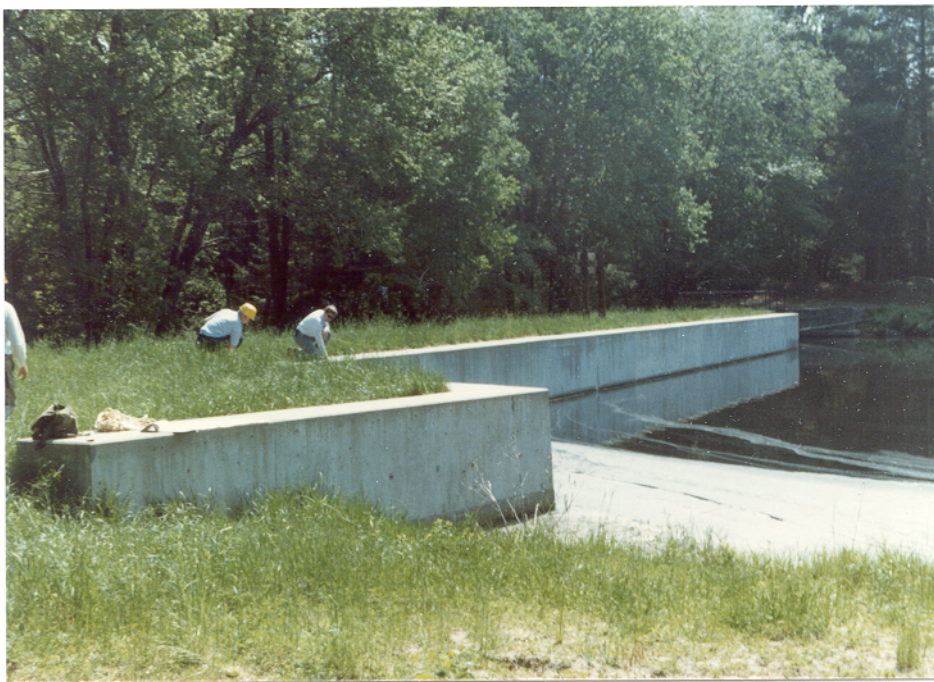
The top of the concrete facing on the upstream side was about 5 feet above pond level at the time of inspection, and the upstream water depth at the dam was about 10 feet. Five vertical hairline cracks were noted in the concrete facing with a maximum width of about 1/10 inch and spaced about 20 feet apart.

(c) cracks in the concrete upstream facing,

Figure 2 - View of the upstream face of Drown's Dam taken from the west bank.

c. Specify the repairs to seal the cracks in the concrete facings.

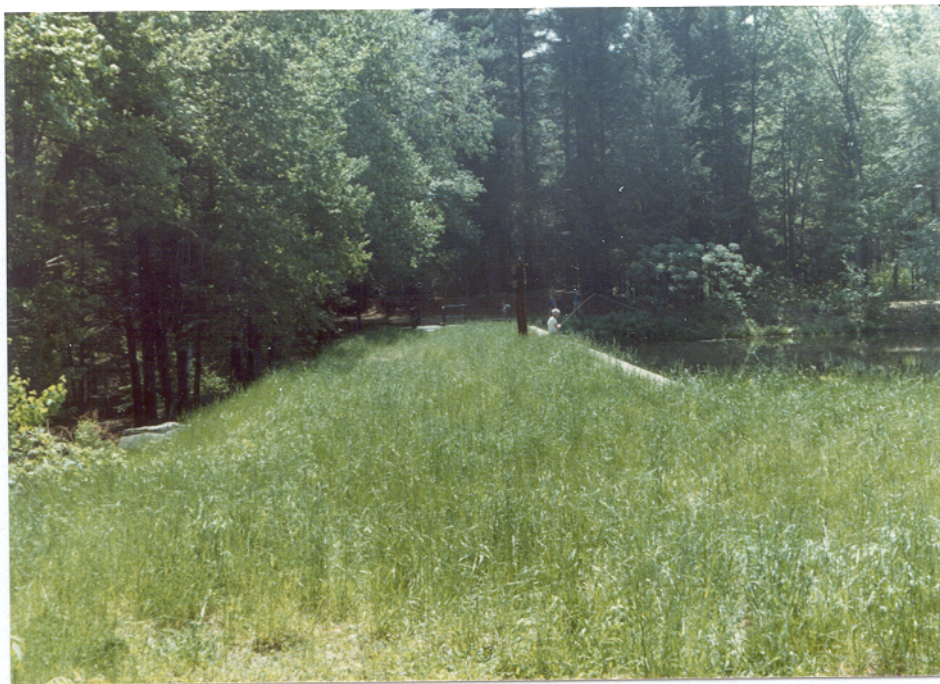
Figure 3 - Looking southeast along the center of the dam from the northwest abutment.

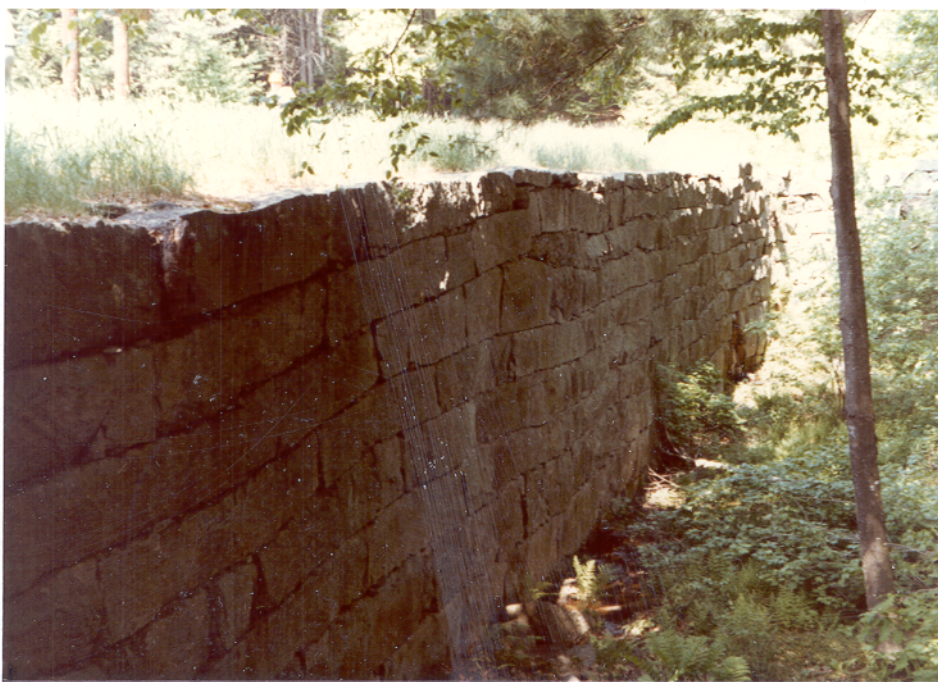
Figure 4 - Looking northwest at the downstream face of the dam.

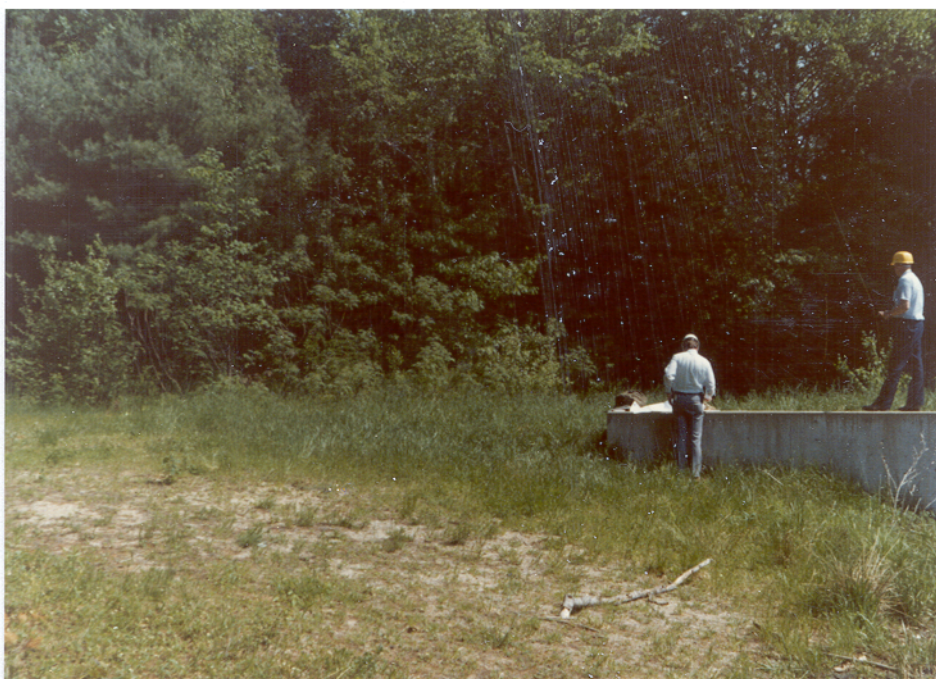
Figure 5 - Looking northeast at the emergency spillway located at the northwest end of the dam.

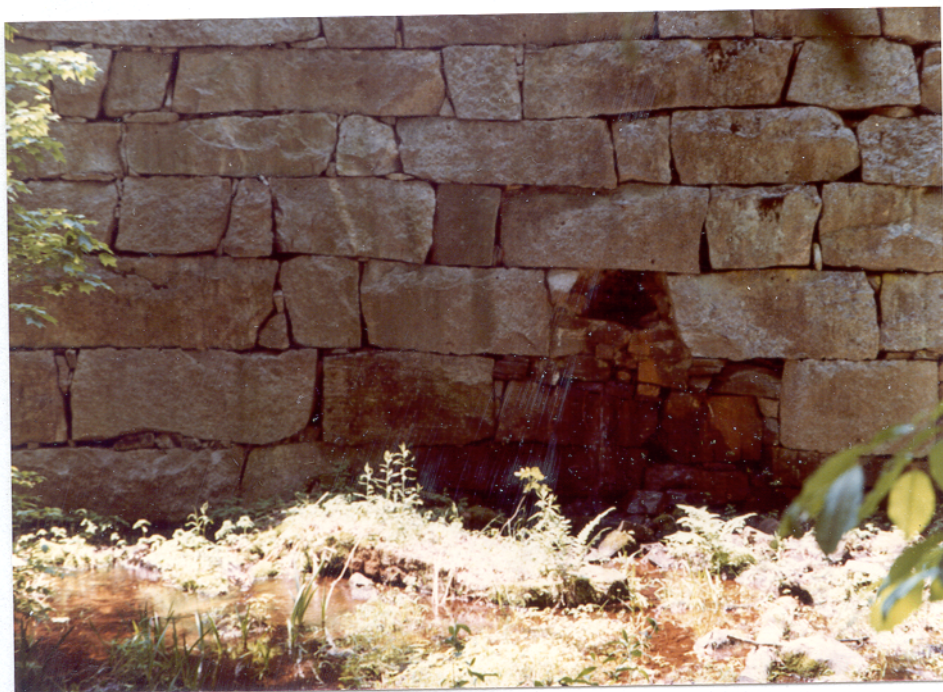
(b) leakage through the penstock plug itself,

(1) Embankment. Visual observation indicated two problems relating to structural stability: (a) leakage through the plug at the old penstock opening through the dam, and (b) seepage through and/or under the dam. The hairline cracks in the concrete facing on the upstream wall of the dam are of minor significance in their present condition, but could lead to future problems if they are not repaired.

- (1) overtopping potential,
- (2) seepage at the toe of the dam in the vicinity of the plugged opening of the former penstock, and
- (3) leakage through the penstock itself.

Figure 6 - Looking at the downstream face of the dam. Note the 48 inch penstock, partially filled with rubble and concrete, and the seepage coming from this area.

b. Design the remedial measures needed to eliminate or control the seepage at the downstream toe and the leakage through the penstock.

(1) Monitor seepage and leakage at the dam on a weekly basis.

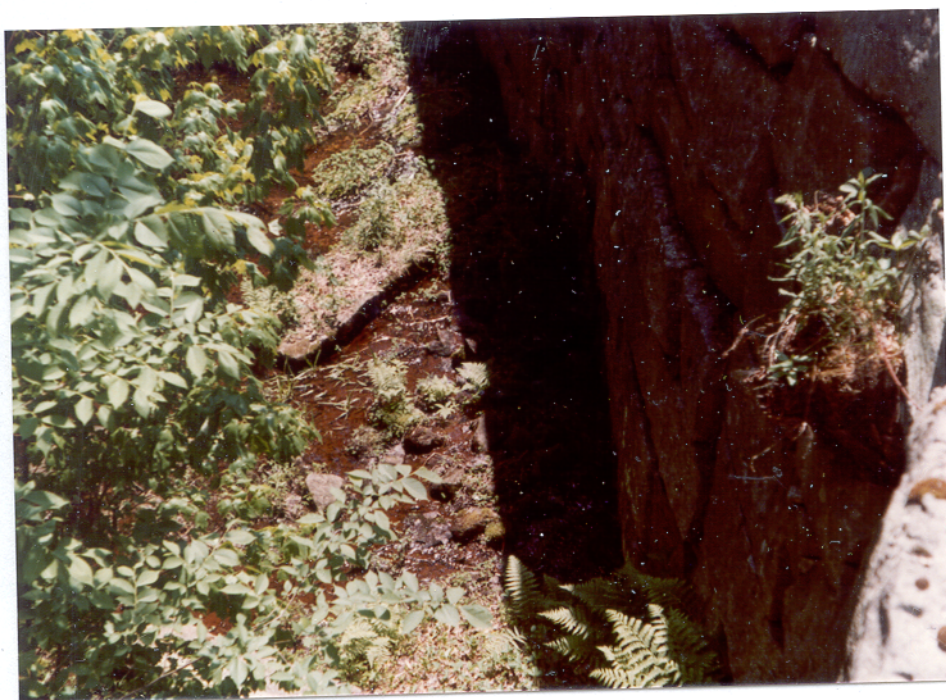
Seepage of about 1 cfs was observed near the downstream toe at the left end of the dam. A small part of this seepage

Figure 7 - Seepage at the downstream toe of the dam about 80 feet from the northwest abutment. Note the tree stump near the top of the dam at the right edge of the photo.

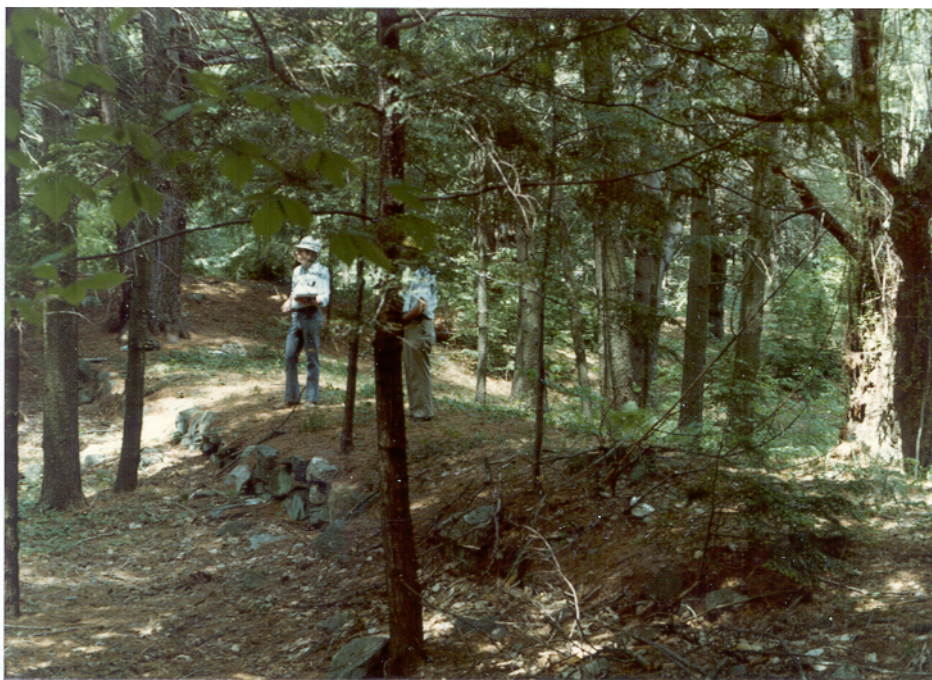
Figure 8 - Looking west at the upstream face of the east dike.

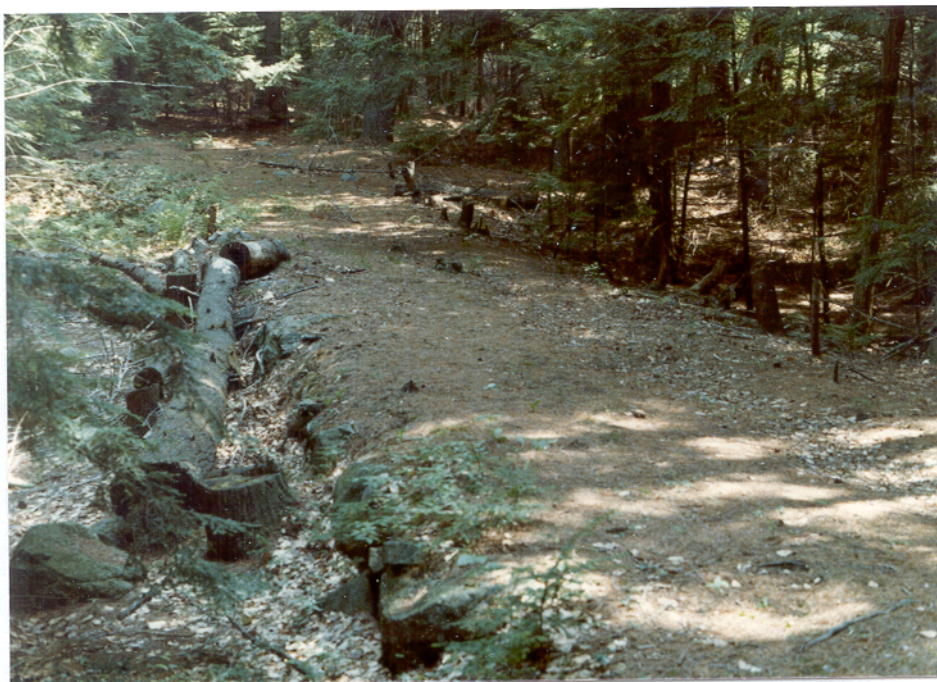
Figure 9 - View looking north along the downstream face of the west dike.

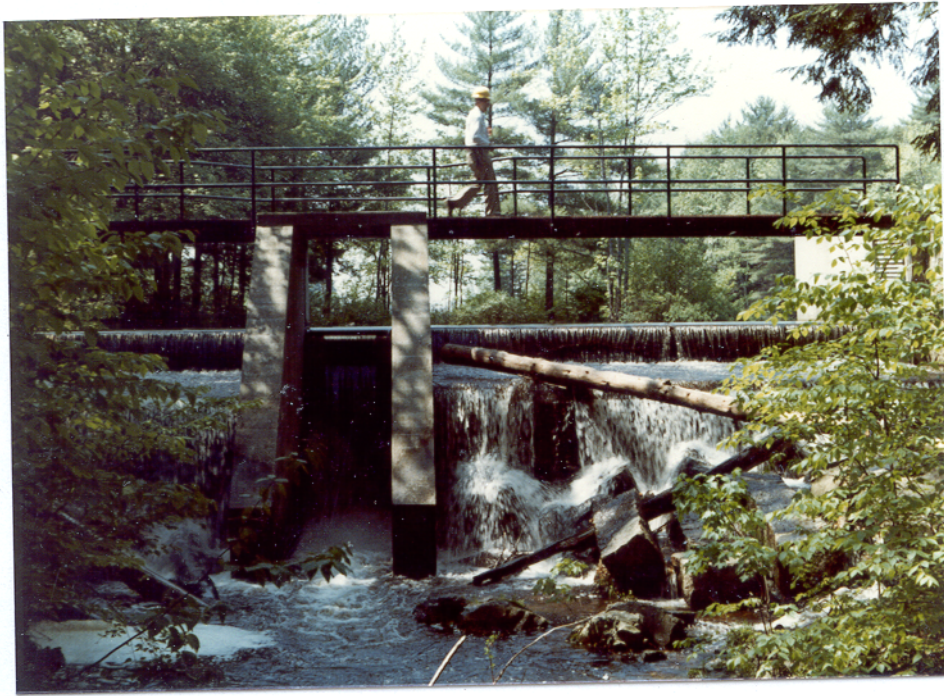
(2) The spillway consists of two 21-feet long fixed-level concrete overflow sections and a 4-foot wide stoplog section. (See Appendix C - Figure 10.) In general, the concrete is in good condition. Surface erosion of concrete is limited to areas in contact with water and consists primarily of the loss of surface laitance. Two hairline cracks and one area of minor spalling were observed on the downstream face of the buttress walls at the stoplog spillway, just above the level of the concrete overflow-spillway apron. The spalling appears to be due to mechanical damage rather than weathering. The slots for the stoplogs are in good condition, but the stoplogs could not be inspected because water was discharging over the top of the stoplogs.

(e) cracks in the concrete buttress walls at the stoplog spillway,

(2) Appurtenant Structures. The hairline cracks and minor spalling in the buttress walls at the stoplog spillway and the rusting of the service bridge are of minor significance in their present condition, but could lead to future problems if they are not repaired or corrected.

Figure 10 - Looking upstream at the overflow spillways and the narrow stoplog spillway.

(3) Repair the cracks and spalling in the concrete buttress walls of the stoplog spillway and provide a corrosion-resistant coating on the service bridge.

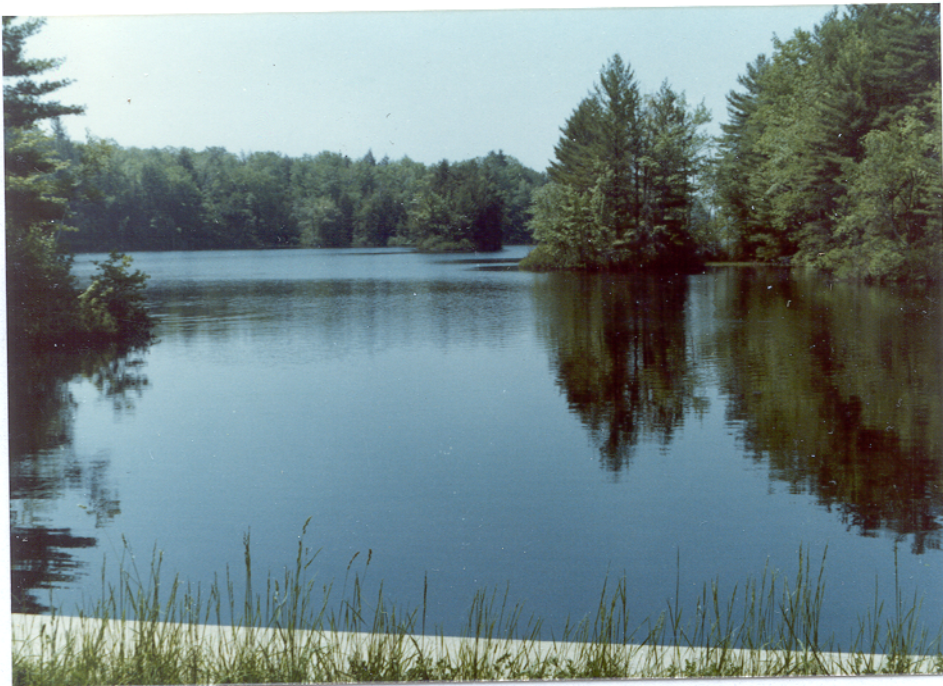
Figure 11 - Looking upstream at Pawtuckaway Pond from the center of Drown's Dam.

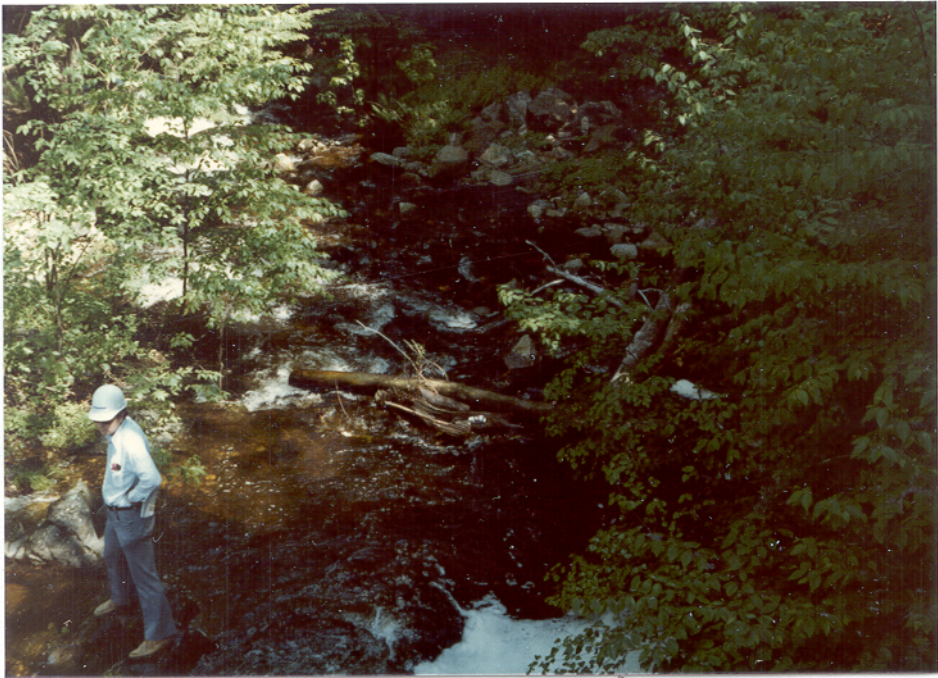
c. Visual Observations. No visual evidence was disclosed that would indicate that the dam has ever been overtopped. Debris may partially obstruct the spillway opening and cause a reduction in the capacity of the spillway during a flood occurrence.

Figure 12 - Looking at the channel downstream of the spillways from the service bridge.
